TECHNICAL NOTE

CHEVROLET

Subject: ANTI-DIESELING SOLENOID
 BRACKET BREAKAGE - 1968
 CHEVROLET W/L-6 ENGINE

Subject: ENGINE DIESELING - 1968 PASSENGER
 AND TRUCK WITH L-6 ENGINE

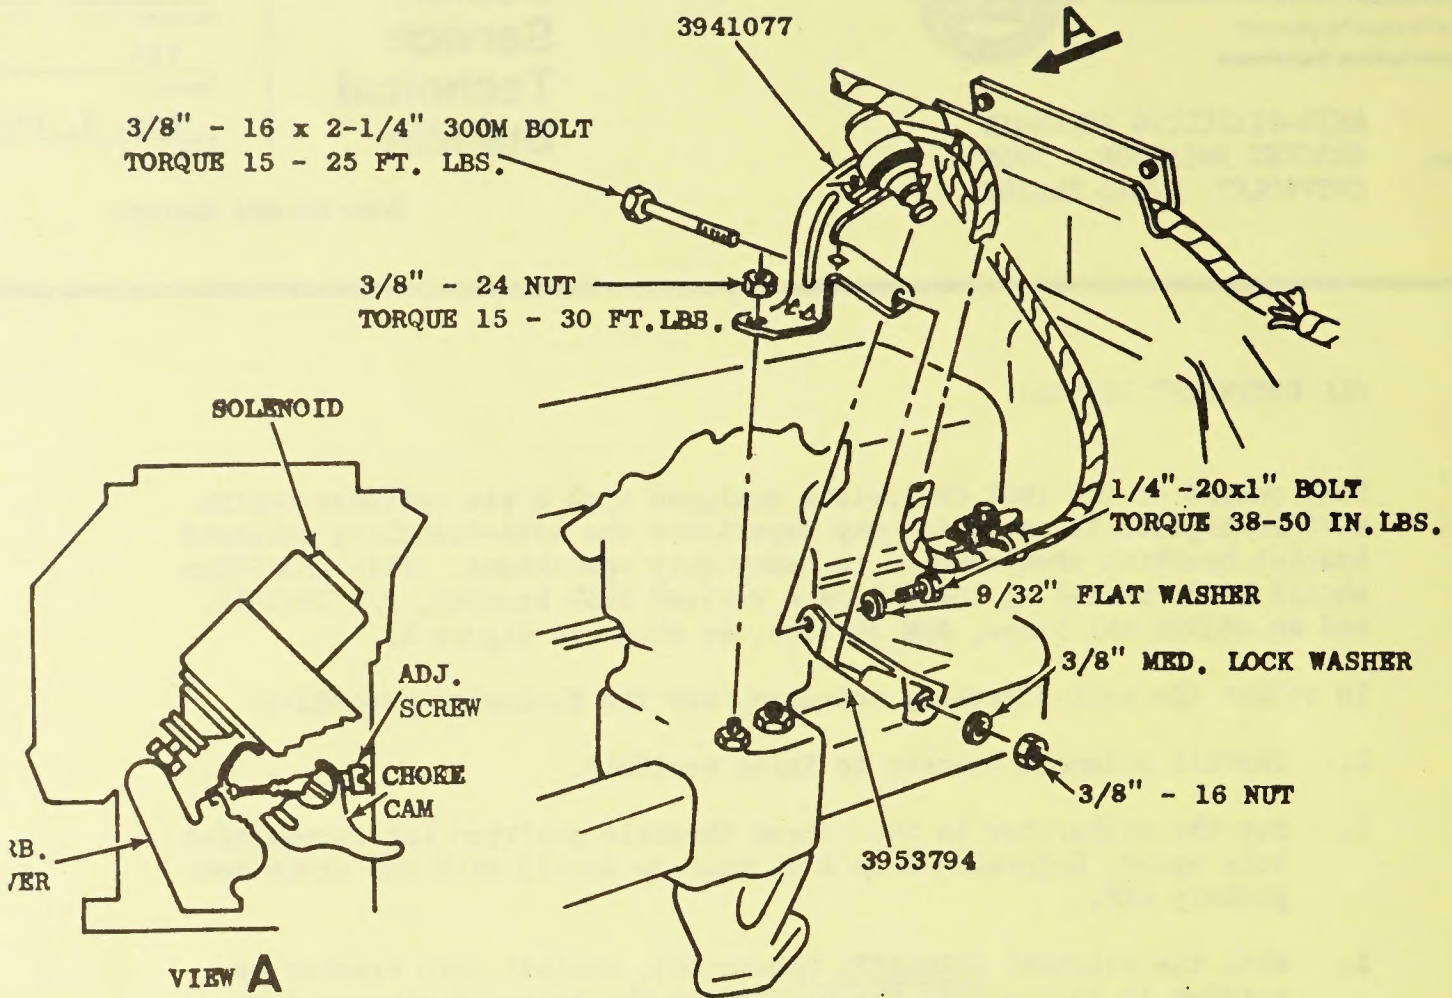
FIGURE 1

Some owners of the 1968 Chevrolets equipped with a six cylinder engine with Powerglide transmission may experience the anti-dieseling solenoid bracket breaking when exposed to heavy duty operations. This condition should be corrected by installing a revised 1969 bracket, P/N 3941077, and an additional brace, P/N 3953794, as shown in Figure 1.

To adjust the anti-dieseling solenoid, use the following procedure:

1. Install solenoid bracket to inlet manifold.
2. Set the carburetor in the closed throttle position (at recommended idle speed, Reference Step 1 on tune-up decal) with the choke completely off.
3. With the solenoid ENERGIZED (power on), install into bracket by sliding it down within the bracket so the solenoid plunger just slightly contacts the carburetor lever. Tighten the bracket strap to secure the solenoid in place.
4. Back carburetor idle adjusting screw out 3/4 turn (counter-clockwise). This results in a clearance between the carburetor idle adjusting screw and its stop on the lever of approximately .025".

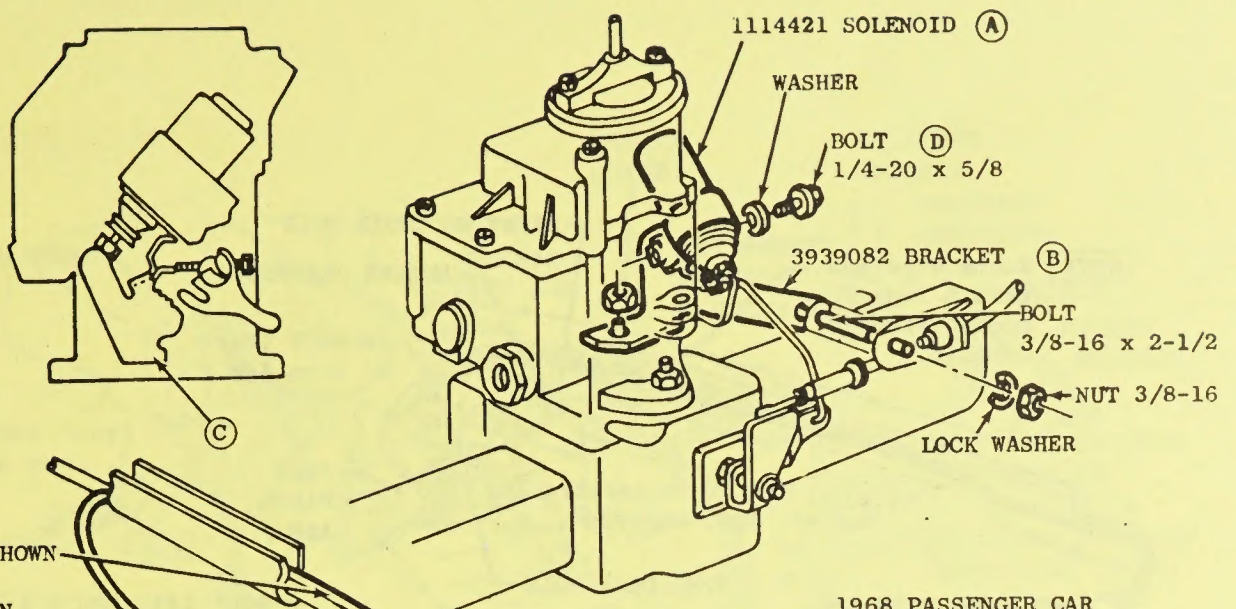
1968 PASSENGER CAR
6 CYLINDER SOLENOID MOUNTING

Reports of engine dieseling after the ignition has been turned off, have been reported on some 1968 vehicles with L-6 engines and manual transmissions.

This condition is generally caused by improper idle speed, timing, and/or low octane fuel being used. To correct dieseling complaints in the field, the engine should be properly tuned - refer to appropriate shop manual for engine tune-up specification.

If dieseling still exists on an engine that is correctly tuned, then an anti-dieseling solenoid as used on units with automatic transmissions may be installed. See attached illustrations for procedure.

1. Set the carburetor in the closed throttle position (at recommended idle speed, Reference Step 1 on tune-up decal) with the choke completely off.
2. With solenoid (A) energized, power on, adjust in bracket (B) so that the hex plunger touches the carburetor lever (C) and tighten nut or bolt (D).
3. With solenoid (A), de-energized, power removed, back off the idle adjustment screw on carburetor (1/2) turn. This will set the carburetor at the recommended low idle speed (400 RPM)

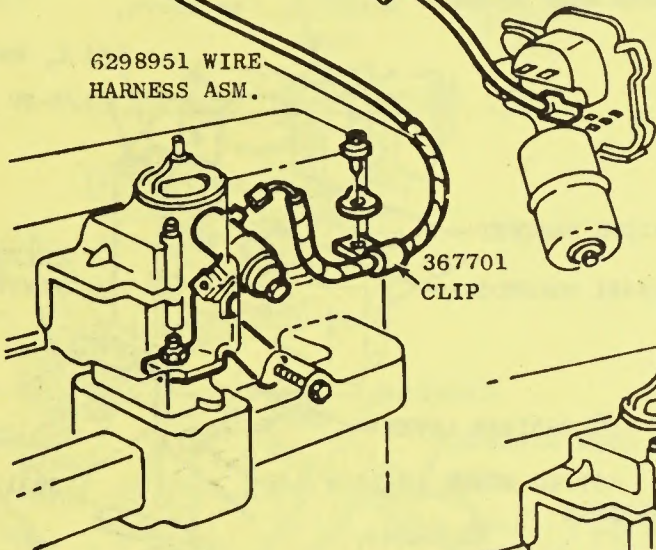
6 CYLINDER SOLENOID WIRING
CHEVROLET

The engine anti-dieseling solenoid installation procedure on the L-6 passenger car has been revised to connect the solenoid wire to the ignition terminal of the fuse panel and not to the windshield wiper motor terminal as shown on Page 3 of the original bulletin.

This change is necessary, for after the ignition key is turned off, there may be sufficient current feed-back in the wiper motor circuit to hold the solenoid plunger in the fast idle position (engine dieseling).

The revised L-6 passenger car solenoid wire installation procedure is the same as shown on Page 4 of the original bulletin titled Wire Assembly To Dash Panel (Truck) except the passenger car installation requires drilling a 3/4" diameter hole in the dash panel. The grommet that is part of the 3942886 truck wire assembly should be positioned on the wire to provide the length needed to reach the ignition terminal of the fuse panel.

ROUTE AS SHOWN
TO SINGLE
TERMINAL ON
WIPER MOTOR
